Sieve Structures to Control Gully Erosion on the Borana Plateau, Ethiopia

RB-24-2015

Research Brief

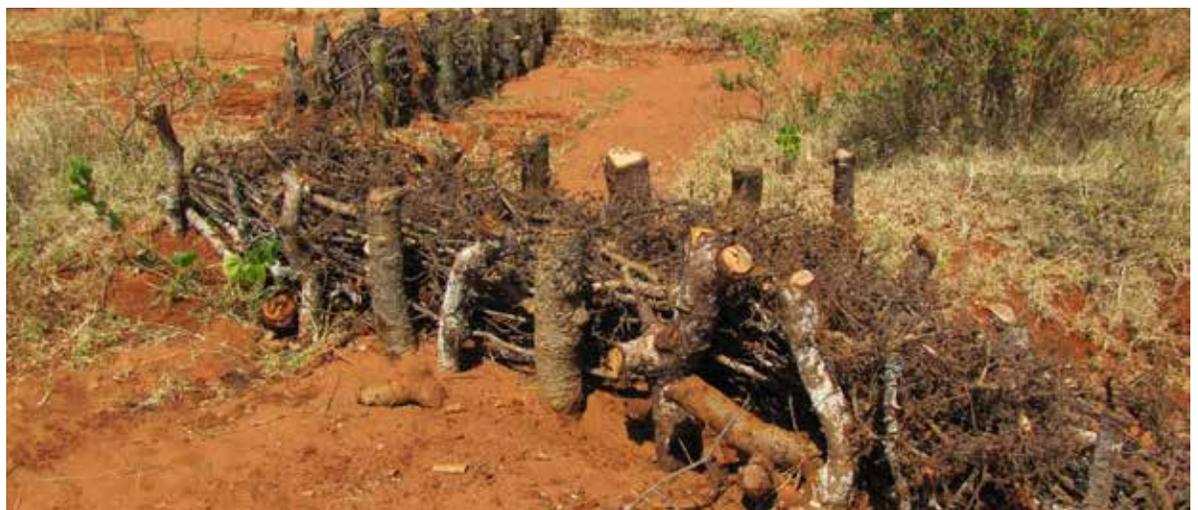
A pair of sieve structures at the confluence of 2 secondary gullies in the Dikale enclosure. The basic design consists of two rows of tree stumps sunk into the gully floor and packed with acacia branches. Some excavation has occurred in sand at the base of the sieve near the camera due to animal activity. (Photo credit: Brien E. Norton).

Sieve structures are ‘porous dams’ that can be made from trees growing near the gully. Posts or ‘stubs’ cut from the main tree-stem are placed upright across the gully, buried into the gully floor and rising 50-150cm above it. Gaps of 10-15cm are left between the upright posts. Branches are then packed horizontally upstream against the row of posts. If sprigs of aloe plants can be harvested from the neighbourhood, they should be planted among the posts where they will grow. Similarly, if stubs from Commiphora trees are available to be incorporated into the row of posts, they too will sprout and together with aloe sprigs form a living sieve. OARI staff have observed stolons of the perennial grass *Cynodon dactylon* and other plants growing into the sieve framework, contributing to the integrity of the structure.

The soil and water conservation team at OARI experimented with different designs of sieve structures. The initial efforts in March-April 2014 comprised a single row of posts, often incorporating aloe sprigs, across shallow depressions. They were effective in reducing water flow and trapping sediment as long as the margins extended across the entire gully depression. The second generation of sieve structures installed in October 2014 comprised two rows of posts 25-50 cm apart. The space between the rows was packed horizontally with *Acacia*

Ten new sieves were examined in a secondary drainage gully running north into the main gully to the east of the Dikale pond. Scores ranged between 2 and 3, with an average of 2.4. Low scores were assigned because of weak edges where water could flow around the sieve, or because of animal excavation activity at the base of the sieve where water could tunnel underneath.

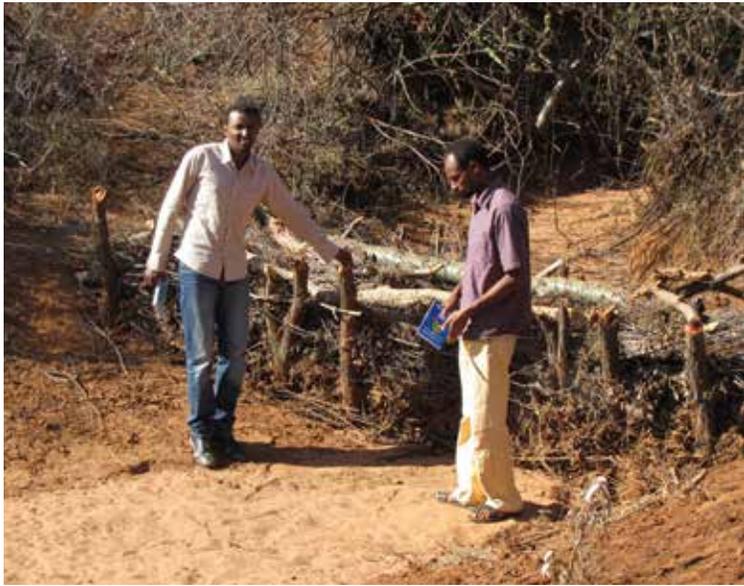
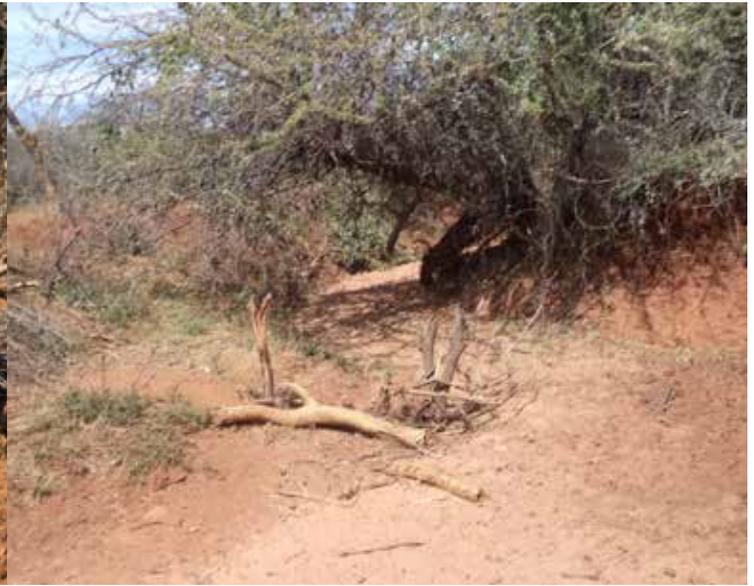
A pair of photos showing (left) an intact sieve structure and (right) the same structure destroyed by flooding in the heavy spring rains. All the branch packing, the large ballast logs, and most of the upright stubs have been washed away in the right photograph. (Photo credits: (left) Brien E. Norton and (right) Bedasa Eba).

Data were collected on the gully length between consecutive sieve structures, the mean width of the gully and depth of sediment. The intent was to compare the volume of sediment in a gully section before and after a rainy season. However, the failure of these three sieves in the long rains of April-May 2015 annulled the exercise.

In June 2015 following the long rainy season, the OARI team surveyed the sieve structures previously monitored. In general, the sieves in the relatively short secondary gully had maintained their structure, serving to slow gully flows and capture sediment. Sieves that had received a low score of 1.5 were ineffective in stopping erosion around the exposed edges. The three sieves in the deep part of the main gully all failed. The packing branches had washed away and only some of the upright stubs remained. The same failure of sieve structures had occurred in the main gully leading into the Harweyu pond.
